# BATH COMPLEX - SURVEY

CARSULAE BATHS RESEARCH PROJECT - SAN GEMINI PRESERVATION STUDIES

## Comparative Analysis of Different Survey Method Products

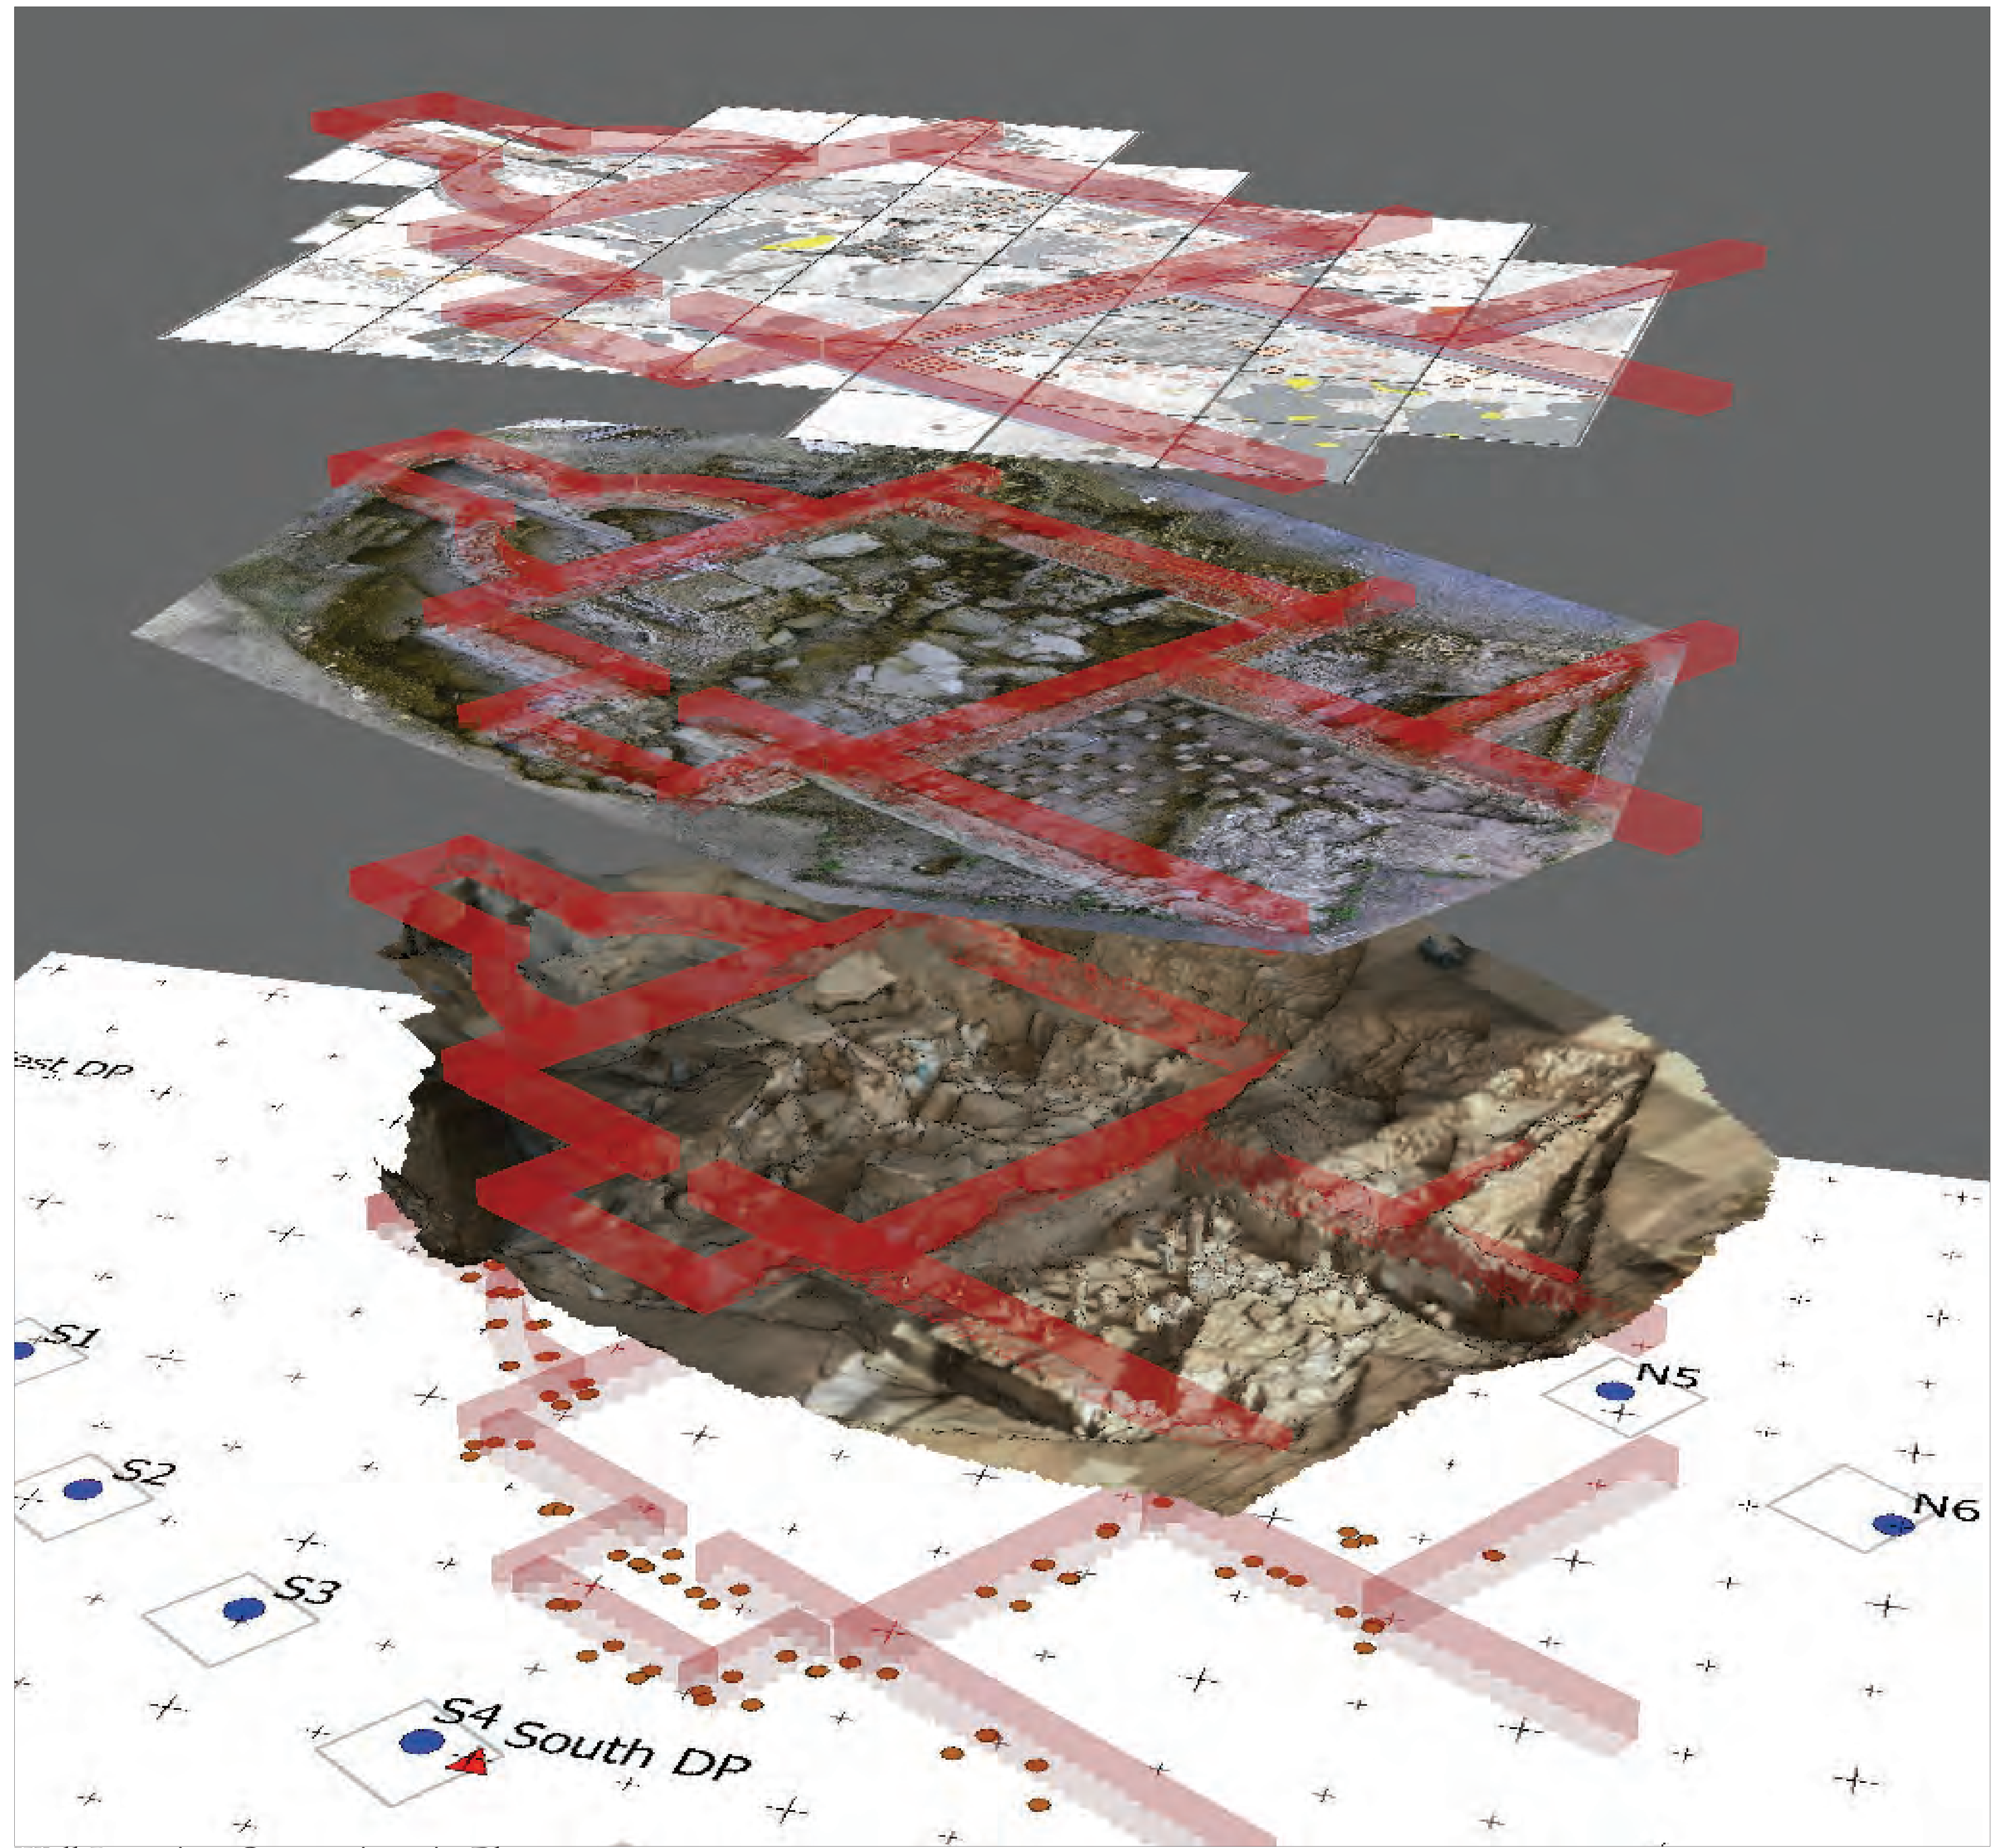
Wall Location Comparison in Plan

Although not a rigorous analytical process, comparison undertaken between each image using known measurements from the site identified some inconsistencies in each of the images. As a baseline dataset has not been properly established in order to provide a suitable control by which all images can be measured, it is impossible to provide any conclusions over the accuracy if one method over another in this particular case. As previously mentioned controlled comparisons are available in the scientific literature. The results do indicate that there are measurable discrepancies between each image, and therefore these discrepancies must be taken into consideration when using one image or another as a reference.
