# BATH COMPLEX - WALL TYPES

### CARSULAE BATHS RESEARCH PROJECT - SAN GEMINI PRESERVATION STUDIES

## WALL CONSTRUCTION TYPES

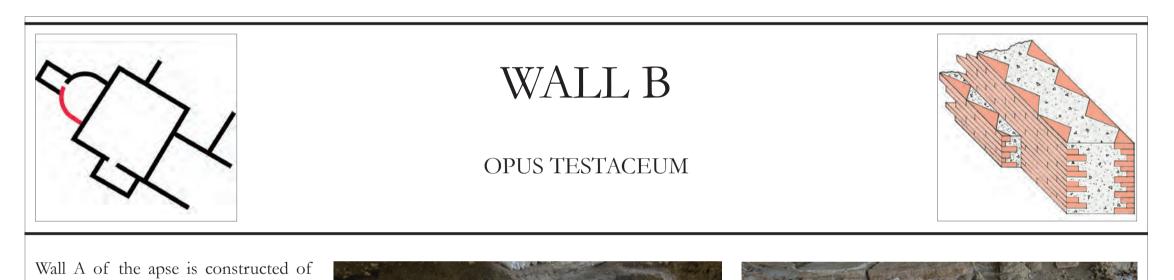
opus testaceum varying in thickness from 61 to 65cm. On the interior of the wall is an 18-20cm wide ledge built up of opus testaceum, and roof tiles. This ledge would've supported the floor of the plunge pool. This side has elements at a certain height sticking out of the structural wall suggesting the original height of the raised floor. Wall A also has a fragment of interior finish nearly flush with the ledge underneath There is no sign of cavity between the Wall B - Interior structural wall and the interior finish, however there are remains of pilae stacks on the floor. There is an opening on the furthest North side of the apse (between walls A and B) with large stone blocks of spolia on both sides. There are spolia from funerary monuments scattered around the outside of the wall.

Wall thickness (cm): 65, 61, 61

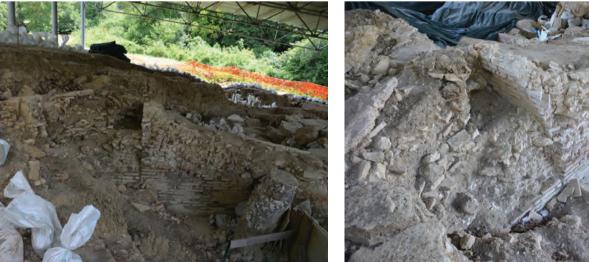
Wall B - Exterior

outside approximately 13-14 cm wide. On the outside there is around 4 cm of plaster. There is the same plaster also at the apse. Within the apse the pilae are completely against this wall.

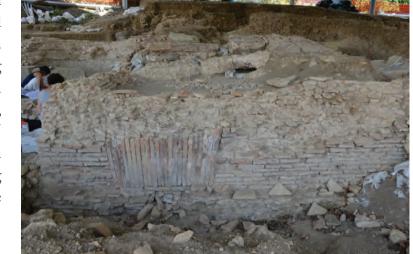
Wall E - Exterior

Wall E is constructed of opus testaceum and is 60.3cm thick on average. The wall has a small opening on the west end with large terracotta voussoirs forming a jack arch. On the exterior the wall has a 14cm deep ledge at the bottom, probably used to support some kind of cladding. The walls of the large room (tepidarium) have terracotta facing sitting on a 13cm ledge. The pilae are 10-15cm from the wall.

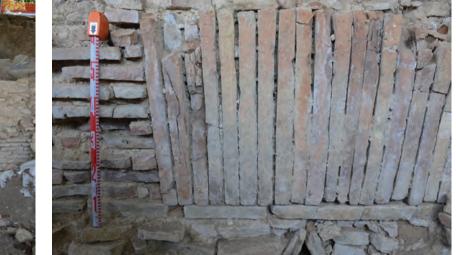
Wall thickness (cm): 62, 59, 60, 60

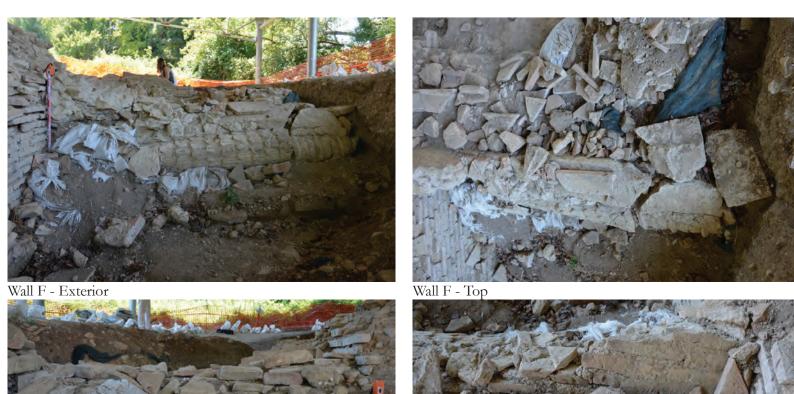
Wall F is built of opus testaceum approximately 62cm thick. On the inner side there is a ledge made of partial roof tiles. Within the wall structure there is a stone opening jamb with an engaged column covered in laural leaves used as a fill element. This jamb has shifted from it's original location causing the wall to fall outward. It appears that part of the column might have projected out of the wall surface. The structural part of the wall has fallen outward and amongst the bricks and stones a remarkably large Wall F - Exterior glass window pane has been found. measuring approximately 30 cm square.

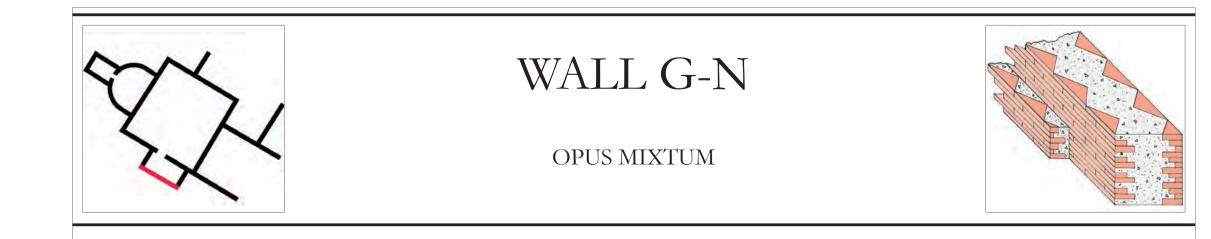
Wall thickness (cm): 62 (only one

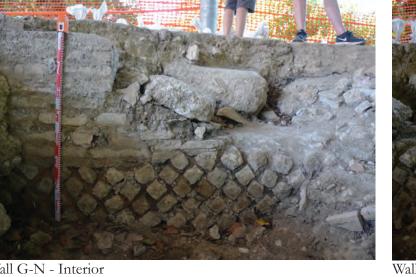
Vall G-N - Interio

Wall G-N is built in opus mixtum and is 51cm thick on average. We can see opus reticulatum all the way along the bottom portion of the wall and opus testaceum courses above it. On the interior we can find the same ledge as walls L & F These is an opening in the center of this wall, with little visible definition at the sides, and no clear function. Opening may be related to a possible furnace located on the south side of wall G-N.

Wall thickness (cm): 50, 52
